**HIGH ENERGY IMPACT COMPACTION (HEIC) WORKS  
FOR A RESIDENTIAL DEVELOPMENT  
CASTLEGATE, CAERPHILLY, WALES****Job Facts**

Date of HEIC works	Intermittent June to Sept 2004
HEIC unit deployed	3 Sided 27 kJ Unit
Site area	6 Ha
Site development	Residential Development
Contract Duration	8 Weeks

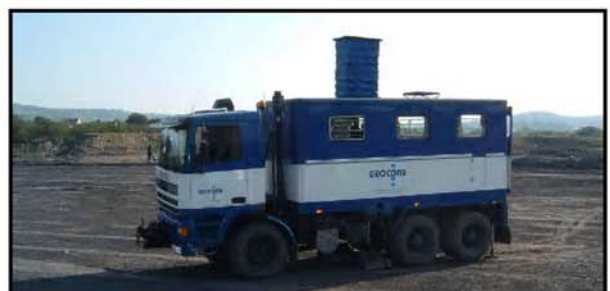
**Plate 2 CPT test rig**

As part of the ground treatment package, LANDPAC included a suite of verification testing carried out under the supervision of an independent Geotechnical Consultant. The verification testing for this site included a suite of SCPT testing, zone load testing and a large scale embankment load test

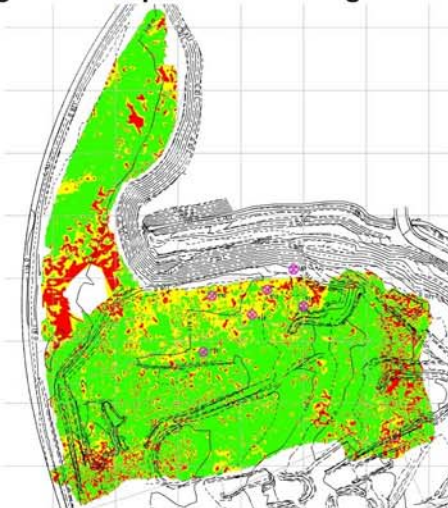
LANDPACs' CIR mapping system allows the deceleration of the impact compactor to be recorded at any point on the site and at any time and the data can be presented as a colour coded drawing. In the drawings below the deceleration increases from red to yellow and green.

**Drawing 1: CIR map at zero coverages**

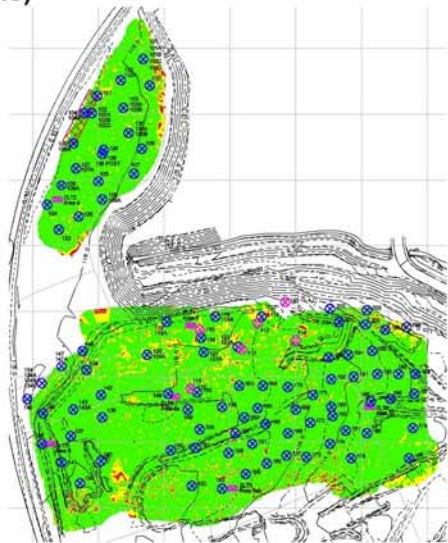
**Drawing 2 CIR map at 30 coverages (including test locations)**

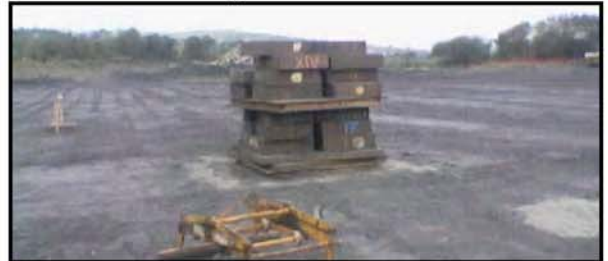
Six zone tests were carried out on 2 m x 2 m square plates which were loaded to apply a pressure of 100 kN/m<sup>2</sup>. The testing indicated Youngs Moduli of between 14 and 18 MN/m<sup>2</sup> over the test increment zero to 100 kN/ m<sup>2</sup>.

**Plate 3: Zone testing**

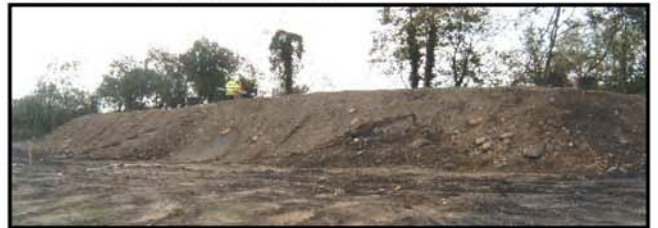
A large scale load test was carried out using an embankment load and a settlement predictions for the proposed raft foundation load of 30 mm was derived by the Geotechnical consultant.

**Plate 4 Trial Embankment**

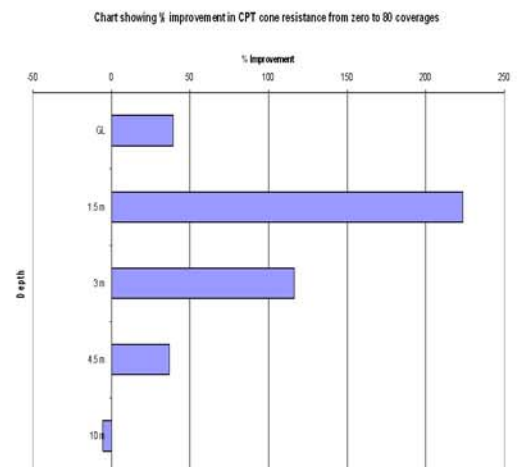
127 SCPT tests were carried out at the site which confirmed uniformity of the treated PFA at the site. The testing confirmed an increase in cone resistance to around 4 m bgl. (see Chart 1)

**Chart 1 SCPT Improvement Profile**
