**HIGH ENERGY IMPACT COMPACTION (HEIC) WORKS
FOR A COMMERCIAL DEVELOPMENT
MANTON WOOD, WORKSOP, ENGLAND****Job Facts**

Date of HEIC works	May 2004
HEIC unit deployed	3 Sided 27 kJ Unit
Site area	1.2 Ha
Site development	Commercial Portal framed Unit
Contract Duration	2 Weeks

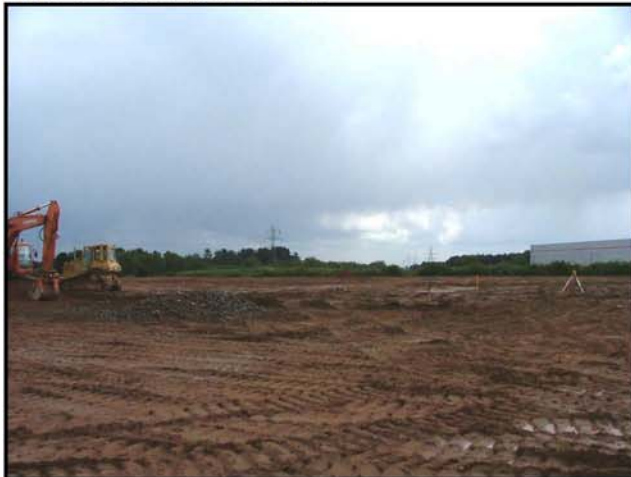
Plate 1 General View of site.

LANDPAC were commissioned to carry out HEIC works at Manton Wood in Worksop. The proposed development occupied an area of approximately 1.2 Ha and included a portal framed commercial building carrying a floor slab load of 50 kN/m² and foundation loadings on pads up to 3 m x 3m of 150 kN/m².

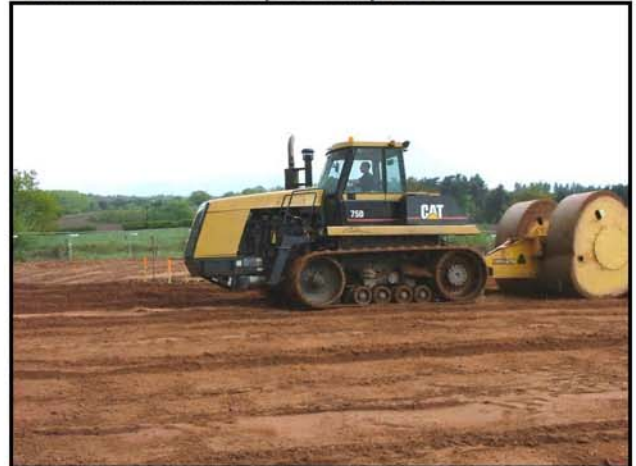
Plate 2 Three sided impact compactor

The works were carried out using LANDPACs' three sided 27 kJ impact compactor with mapping carried out using LANDPACs' proprietary Continuous Impact Response (CIR) apping system.

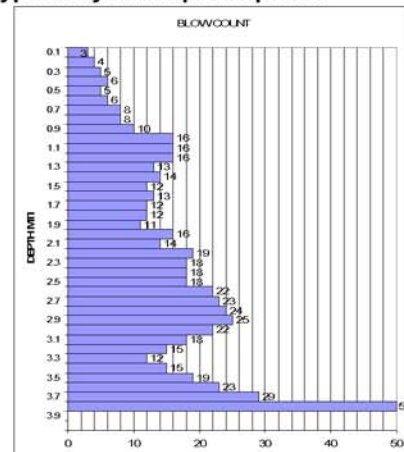
Chart 2 Typical Dynamic probe profile

Plate bearing tests were carried out at the ground surface which indicated much lower youngs moduli of around 5 MN/m². This was due to the dynamic impact of the HEIC causing loosening of the near surface deposits within 200 to 300 mm of the surface.

A typical dynamic probe log confirms the strength profile suggested by the plate testing
